Case stories, Harbours - Mass stabilisation of contaminated dredging mud in Sörnäinen, Helsinki

ABSTRACT: The coastal neighbourhood of Sörnäinen in Helsinki is an old city sector of industrial and harbour area. Nowadays these activities have been replaced by residential building and other city activities, and the infrastructure of the area has been improved after the coastal construction with mass stabilisation in 1998. Many coastal constructions have been carried out by dredging mud from the sea bottom and replacing it with frictional materials (e.g. blasted rock). Dredged mud has been considered unsuitable for any kind of construction purposes and transported to deposit areas. In the Sörnäinen case this relocation of dredged mud was not allowed due to its contamination. Instead, it was decided to reuse the contaminated dredged mud in the coastal structure of the new shoreline of Sörnäinen. For two major reasons it was necessary to stabilise and solidify the mud. Bearing capacity had to be improved in order to avoid stability problems and settlements. Also, any future transport of contaminants to the environment had to be avoided. The chosen method for soil improvement and remedi

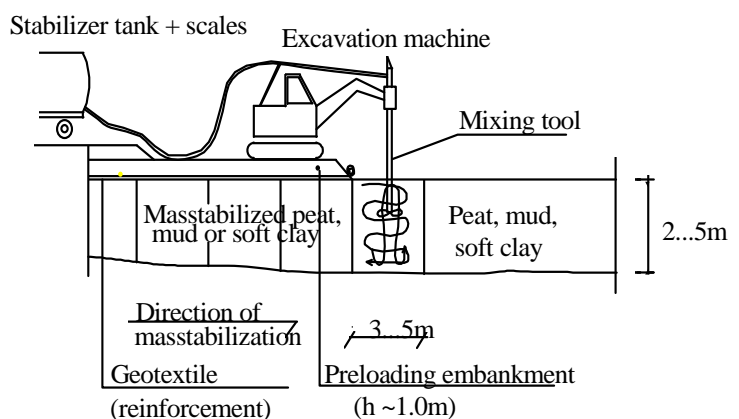
Figure 2. Principle of the mass stabilisation method (EN14679:2005; EuroSoilStab 2002)

Mass stabilisation is a relatively new soil improvement method where dry binder is mixed into peat, mud or soft clay. The procedure is carried out with help of a mixing tool, which has been installed on an excavator machine (Figure 2). Mixing is done both in the horizontal

and the vertical direction so that a hardened soil slab is formed due to the effect of the binder. The mixing tool has been innovated by YIT Ltd in Finland at the beginning of 1990's.

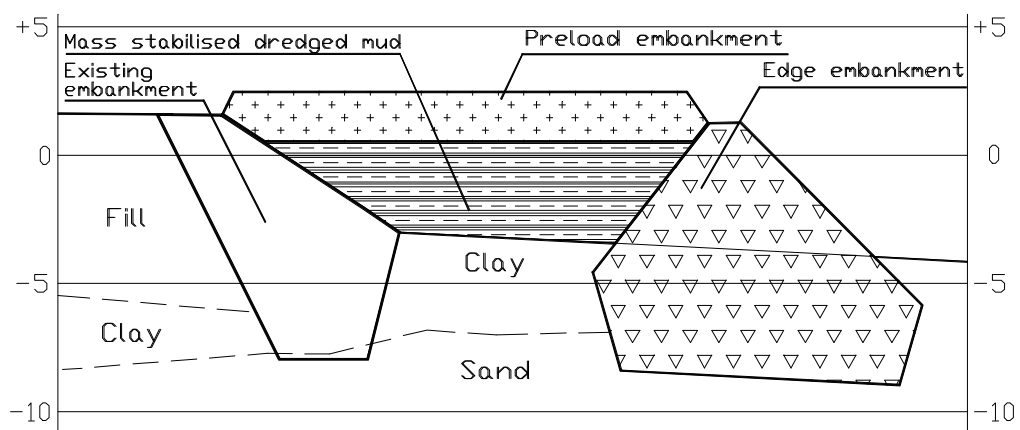
Figure 3. Cross section of the structure in principle, Sörnäinen, Helsinki.

Because of a designed short construction time (only about 7 months) there was no time to wait for the natural hardening and consolidation of the mud. Also, there was a need to find out a solution to prevent spreading of the contaminants in the environment. For these reasons the whole dredged mud layer was chosen to be mass stabilised. The principle of the cross section of the intended structure with the preload embankment is presented in Fig. 3.

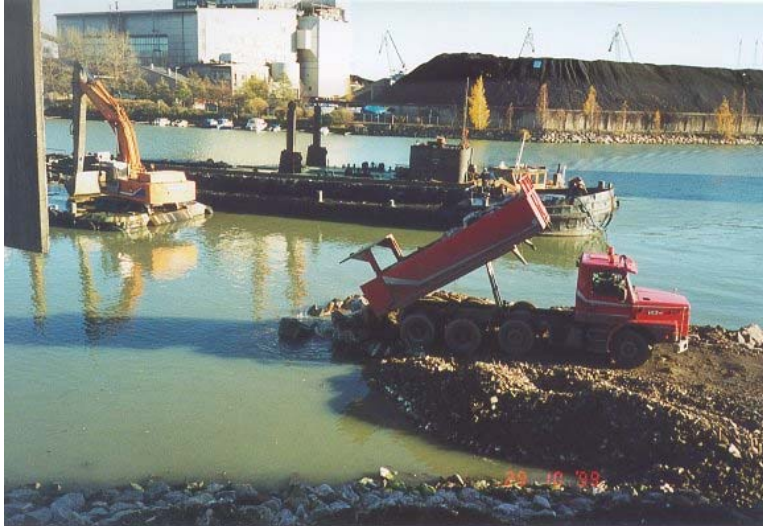
Figure 4. a) Dredging and building of the edge embankment. b) Mass stabilisation work and construction of the compaction layer. c) Preload embankment. Sörnäinen, Helsinki.

Dredging was carried out in two phases. At first, the contaminated top layer of the mud, situating in a place of the edge embankment, was dredged and stored into two barges. In the second phase, the not-contaminated clay layer deeper in the sediment was dredged. The edge embankment was constructed simultaneously. The not-contaminated lower clay material was transported to the relocation area of Taulukari. The boundary surface of these two layers was monitored with help of several laboratory tests in beforehand. Laboratory tests were carried out from the clay being transported to Taulukari during the construction phase, as well. Later, when the construction of the edge embankment had been advancing for a while, the contaminated dredged mud was moved into the basin to the top of the underlying contaminated sediments (Figure 4a). A floating mobile silt fence was used during the whole dredging phase to avoid the spreading of contaminants into the nearby sea area.
